# Uniform Mitigation Verification Inspection Form

| Inspection Date: <u>06/26/2026</u> | | |
| Address: <u>1427 Pelican Bay Court</u> | | Home Phone: |

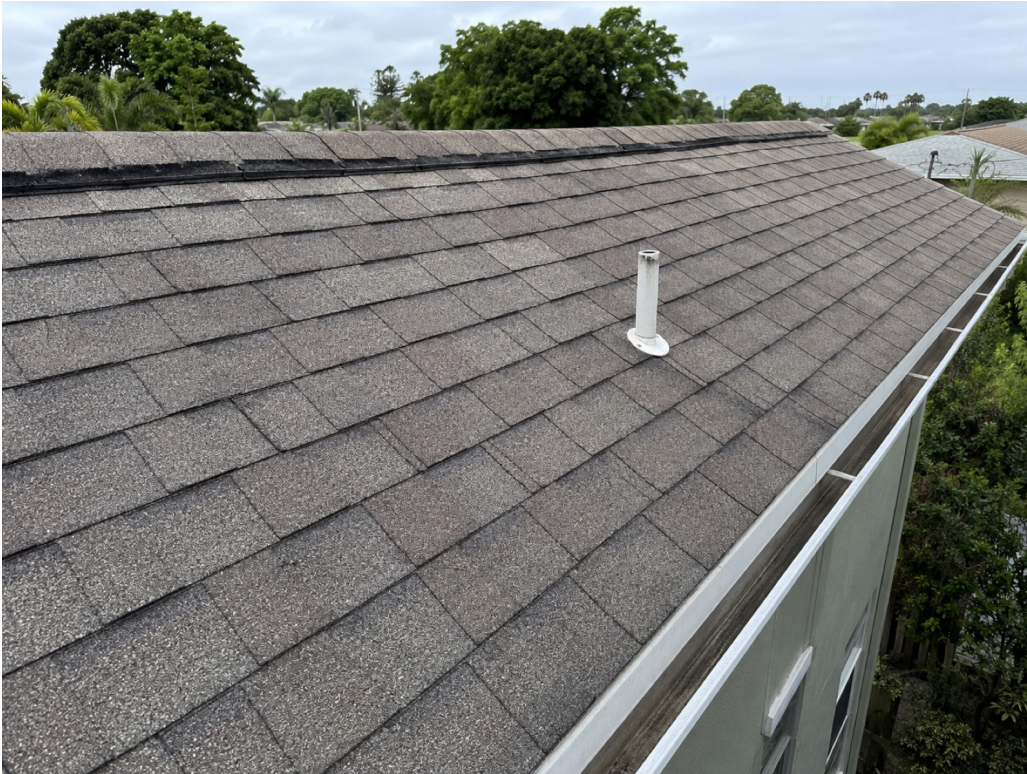
**Q2 Roof Covering — photo 1**

| 2.1 Roof Covering Type: | Permit Application Date | FBC or MDC Product Approval # | Year of Original Installation or Replacement | No Information Provided for Compliance |
|---|---|---|---|---|
| <input checked="" type="checkbox"/> 1. Asphalt/Fiberglass Shingle | <u>04/17/2015</u> | <u>FL10124-R35</u> | _____ | <input type="checkbox"/> |

- ☒ A. All roof coverings listed above meet the FBC with a FBC or Miami-Dade Product Approval listing current at time of installation OR have a roofing permit application date on or after 3/1/02 OR the roof is original and built in 2004 or later.

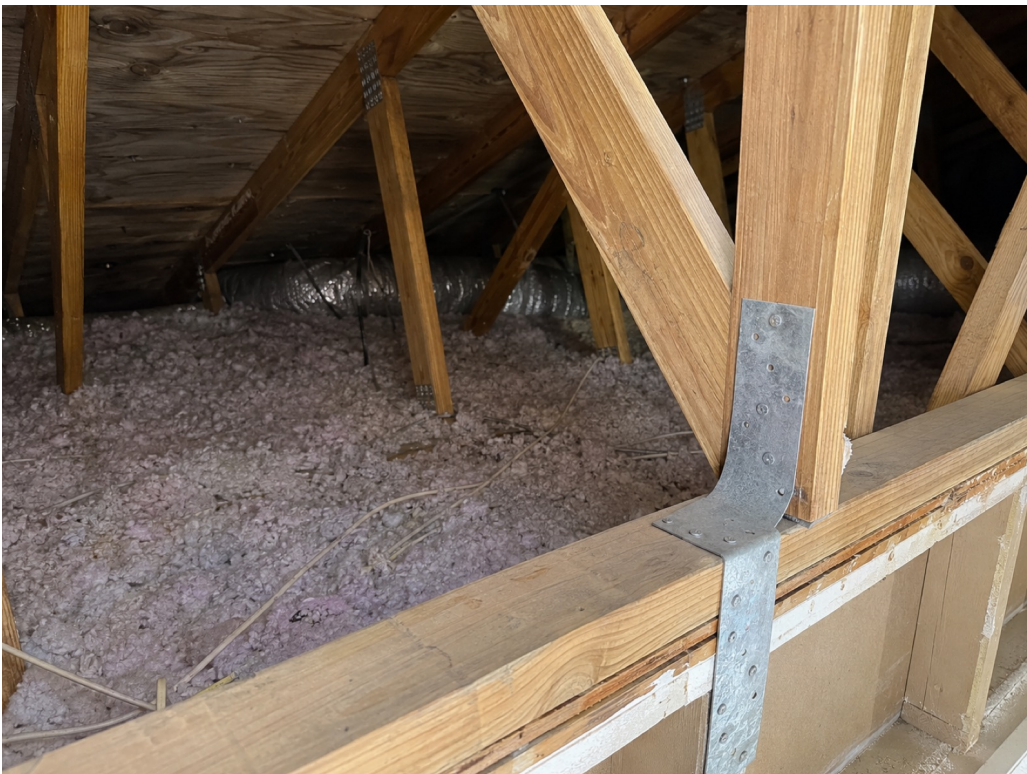
**Q3 Roof Deck — photo 1**

- ☒ C. Plywood/OSB roof sheathing with a minimum thickness of 7/16" inch attached to the roof truss/rafter (spaced a maximum of 24" inches o.c.) by 8d common nails spaced a maximum of 6" inches in the field. -OR- Dimensional lumber/Tongue & Groove decking with a minimum of 2 nails per board (or 1 nail per board if each board is equal to or less than 6 inches in width). -OR- Any system of screws, nails, adhesives, other deck fastening system or truss/rafter spacing that is shown to have an equivalent

or greater resistance than 8d common nails spaced a maximum of 6 inches in the field or has a mean uplift resistance of at least 182 psf.

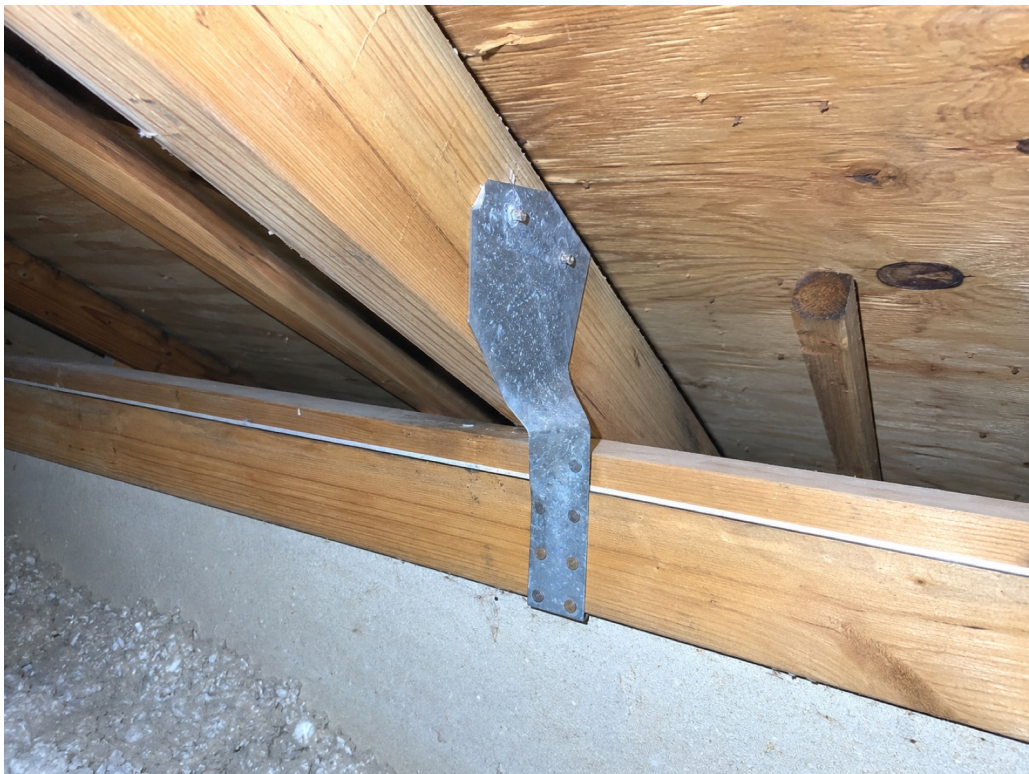
**Q4 Roof-to-Wall — photo 1**

- ☒ B. Clips
  - ☐ Metal connectors that do not wrap over the top of the truss/rafter, **or**
  - ☐ Metal connectors with a minimum of 1 strap that wraps over the top of the truss/rafter and does not meet the nail position requirements of C or D, but is secured with a minimum of 3 nails.

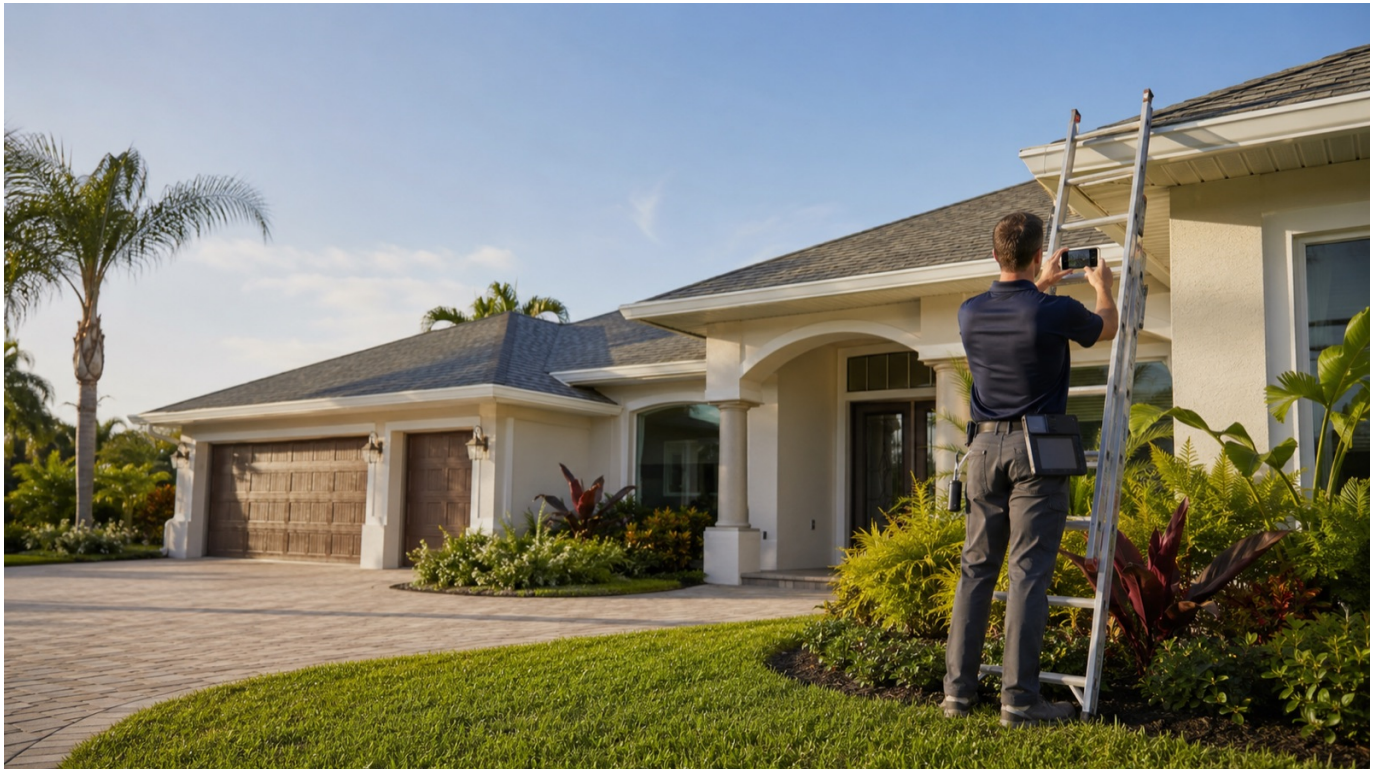
Q5 Roof Geometry — photo 1

- ☒ A. Hip Roof Hip roof with no other roof shapes greater than 10% of the total roof system perimeter.  
Total length of non-hip features: \_\_\_\_\_ feet; Total roof system perimeter: \_\_\_\_\_ feet
- ☐ B. Flat Roof Roof on a building with 5 or more units where at least 90% of the main roof area has a roof slope of less than 2:12. Roof area with slope less than 2:12 \_\_\_\_\_ sq ft; Total roof area \_\_\_\_\_ sq ft
- ☐ C. Other Roof Any roof that does not qualify as either (A) or (B) above.

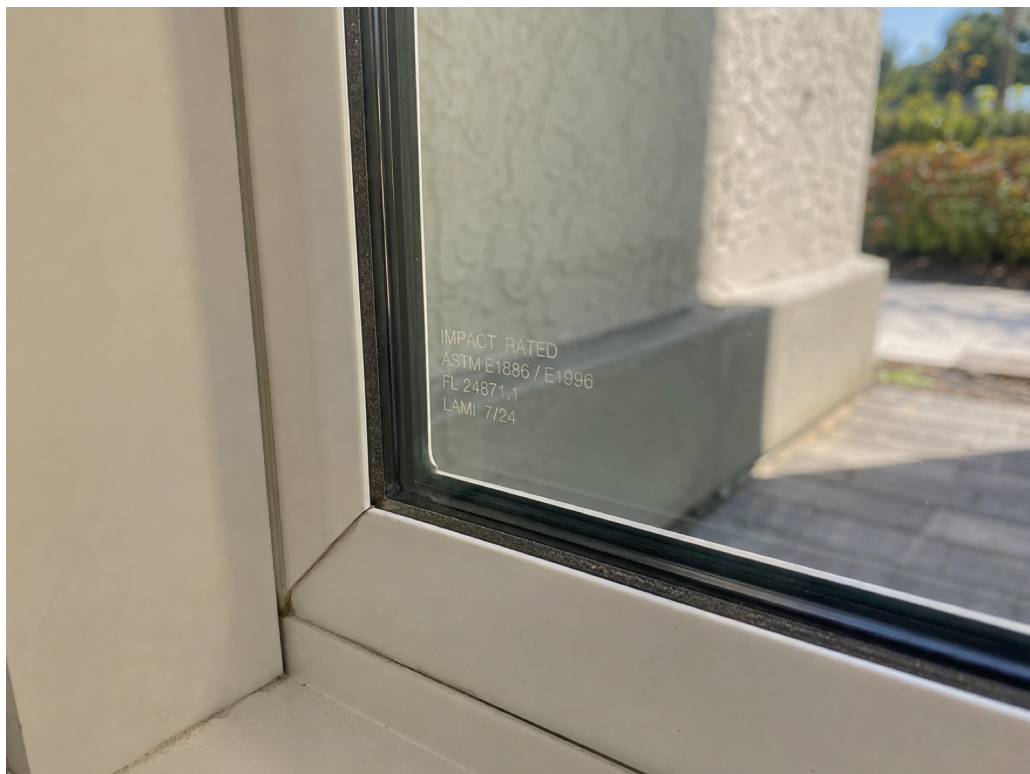
Q7 Opening Protection — photo 1

- ☒ **A. Exterior Openings Cyclic Pressure and 9-lb Large Missile (4.5 lb for skylights only)** All Glazed openings are protected at a minimum, with impact resistant coverings or products listed as wind borne debris protection devices in the product approval system of the State of Florida or Miami-Dade County and meet the requirements of one of the following for "Cyclic Pressure and Large Missile Impact" (Level A in the table above).

☒ A.2 One or More Non-Glazed openings classified as Level D in the table above, and no Non-Glazed openings classified as Level B, C, N, or X in the table above
