# 4-Point Inspection Form

Insured/Applicant Name: Jennifer & David Park Application / Policy #: DEMO-2026-0417

Address Inspected: 1427 Pelican Bay Court, Sarasota, FL 34231

Date Inspected: 06/26/2026

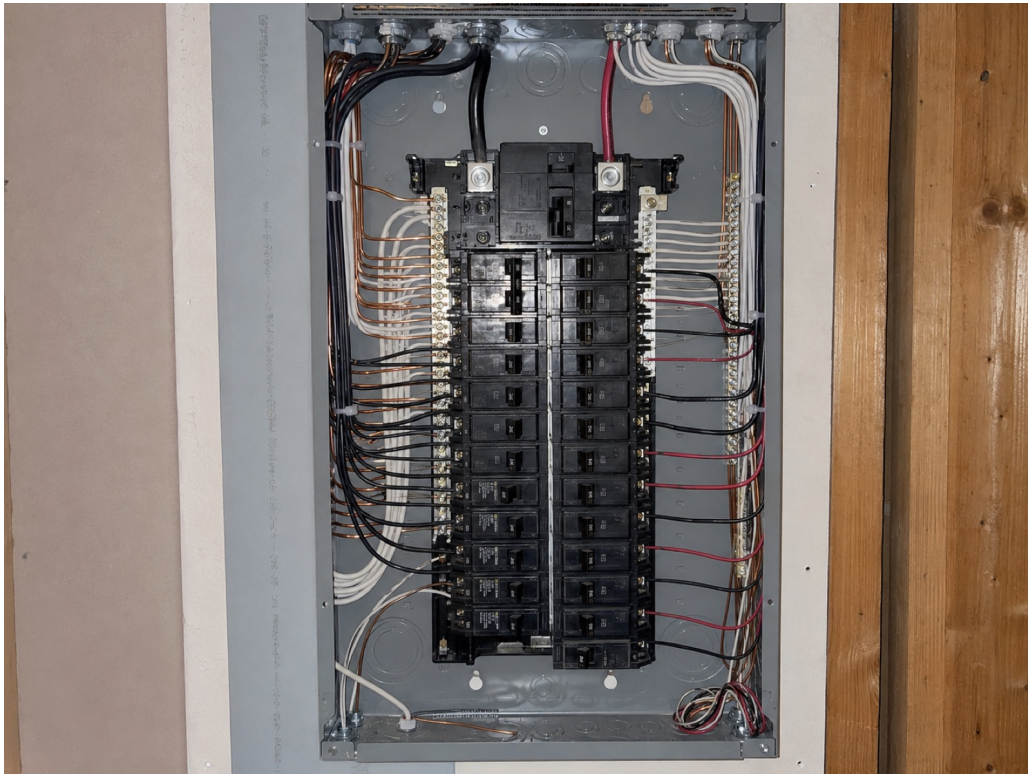
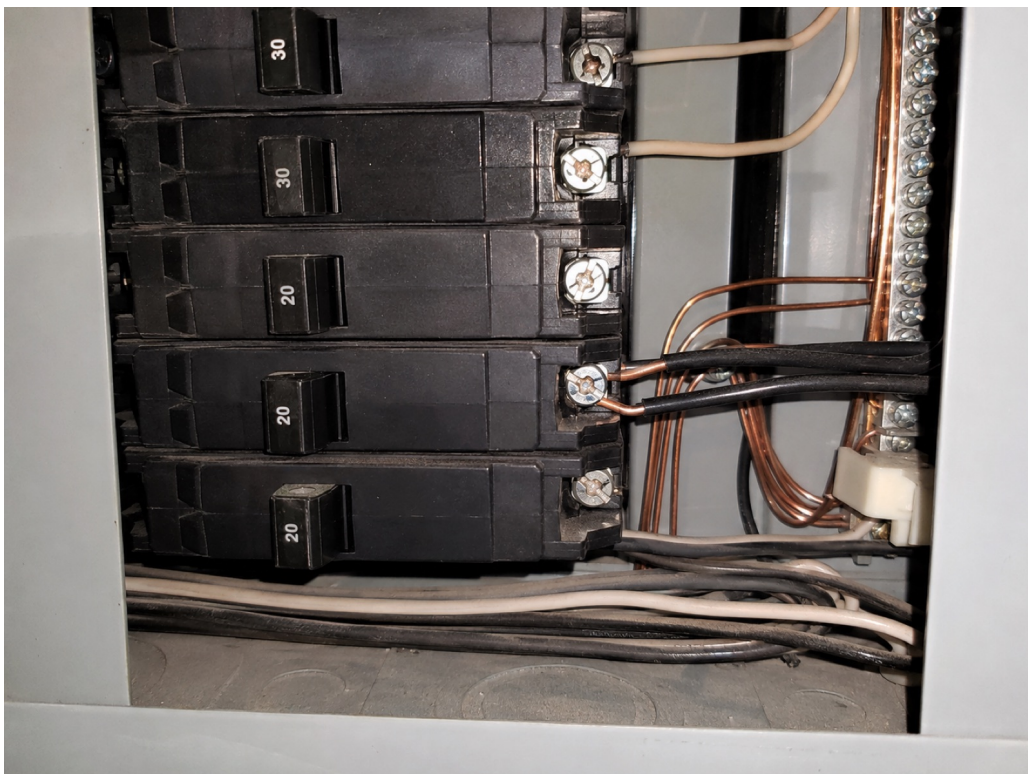
Electrical: Square D 150A main breaker panel, properly grounded and labeled. No double taps, scorching, corrosion, or over-fusing observed.

Breakers sized appropriately for conductors.

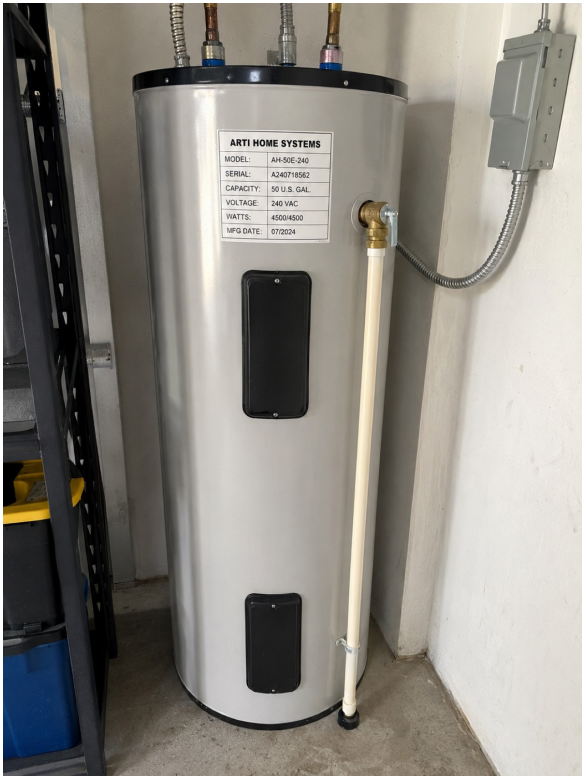
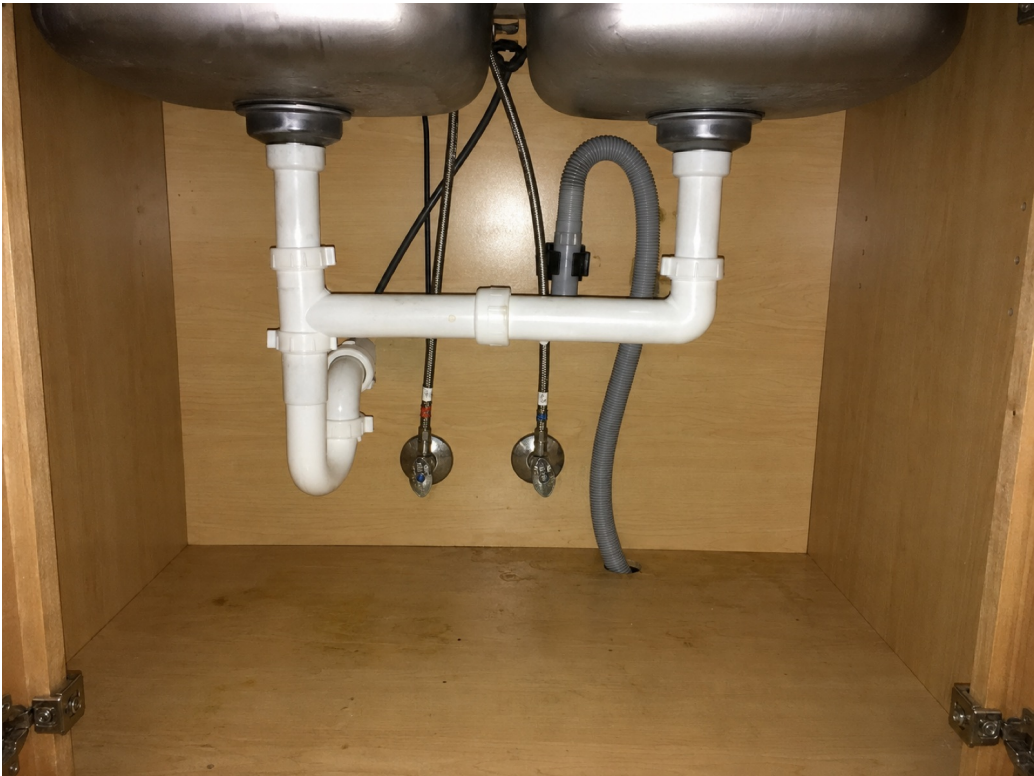
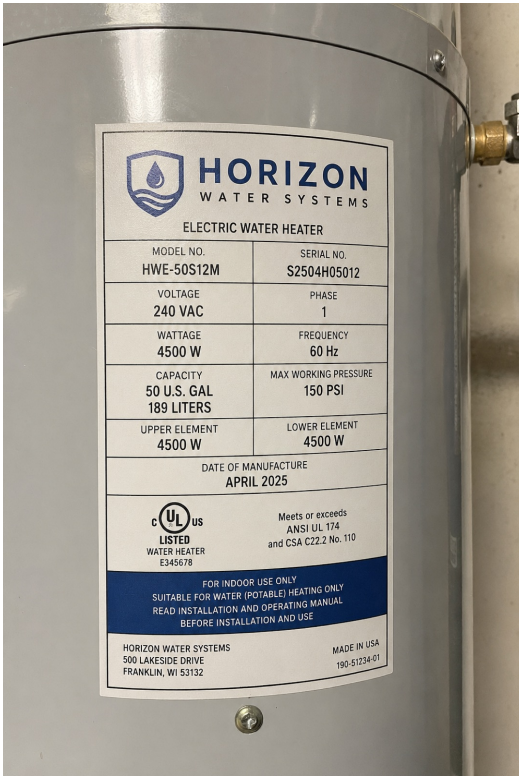
Plumbing: CPVC supply branches with copper at the water heater connections. No active or prior leaks observed. Static pressure 58 psi.

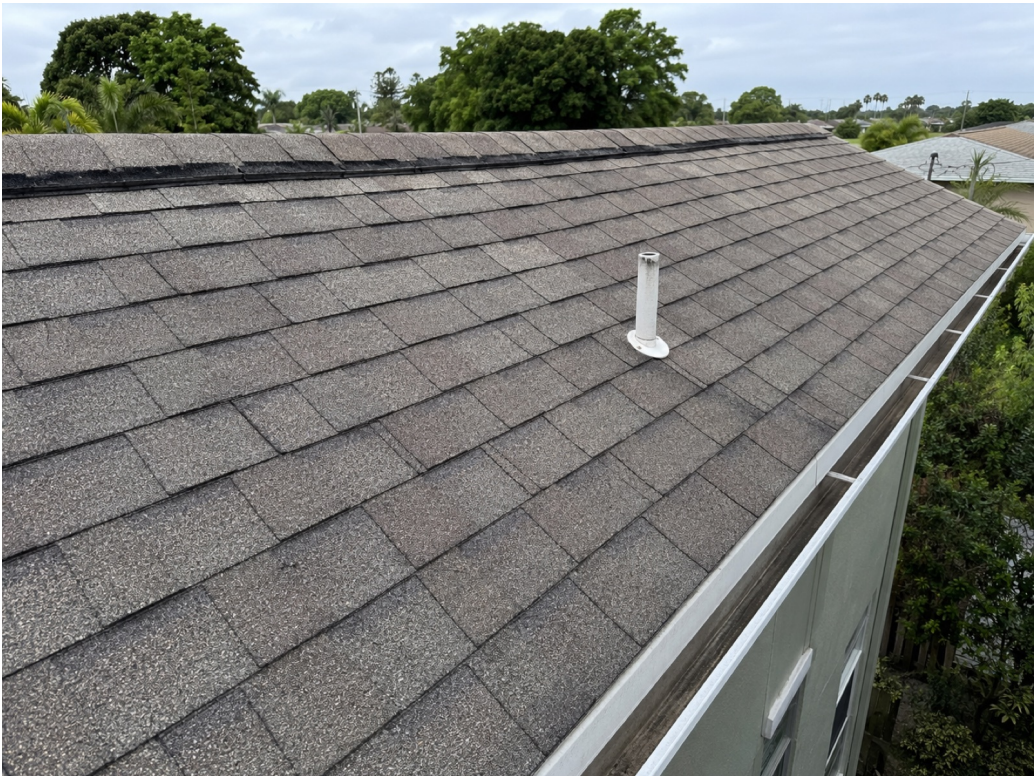
Roof — photo 1

Covering material: Architectural asphalt shingle

Roof age (years): 11 years (re-roofed 2015)

Remaining useful life (years): 8 years
